: Addendum 1 to
: Porton Technical Paper No. 336
:
: Copy No. 92
:
: Date - 3 FEB 1954

The Performance Testing of the E19RM Mechanical Smoke Generator

THE PERFORMANCE TESTING OF THE EIORI MECHANICAL SMOKE GENERATOR

PORTON TECHNICAL PAPER No. 336

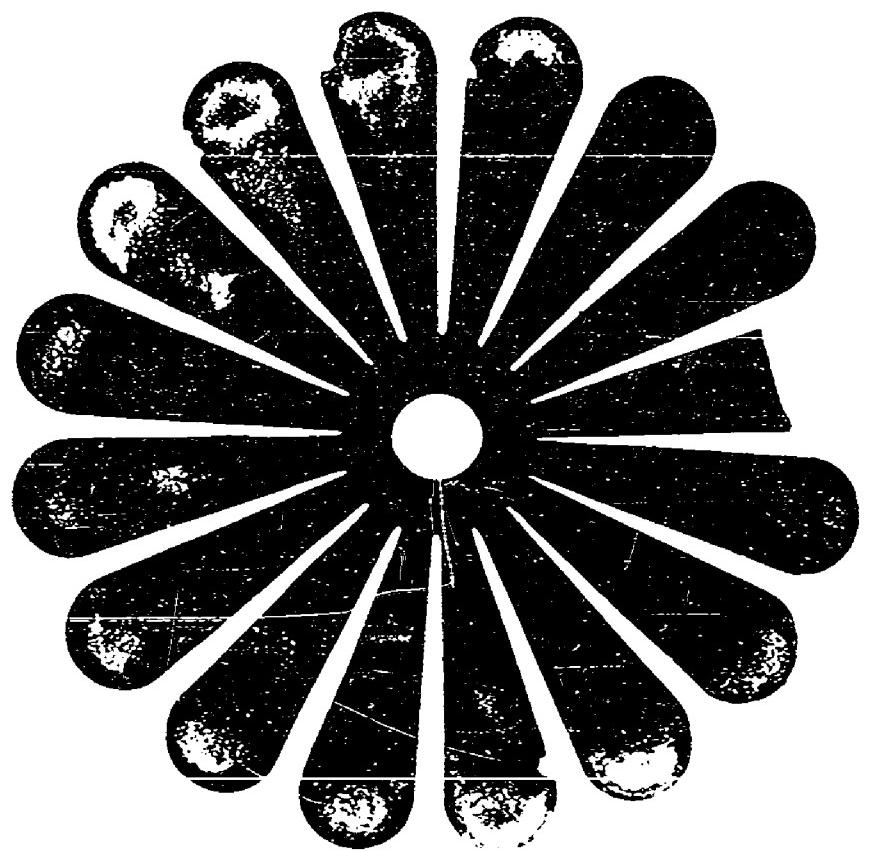
1. During the test three petal valves failed after working periods of 30 hours, 4 hours and $\frac{1}{4}$ hours, respectively.
2. The joint on the flow ejector, at that point where the air connection joins the petrol metering jet holder, fractured during the early stages of the test. A repair was effected by the application of brazing.

FIG. 9. EI9RI MECHANICAL SMOKE GENERATOR
-- PETAL VALVE WHICH FAILED AFTER A
WORKING PERIOD OF 30¹/₄ HOURS

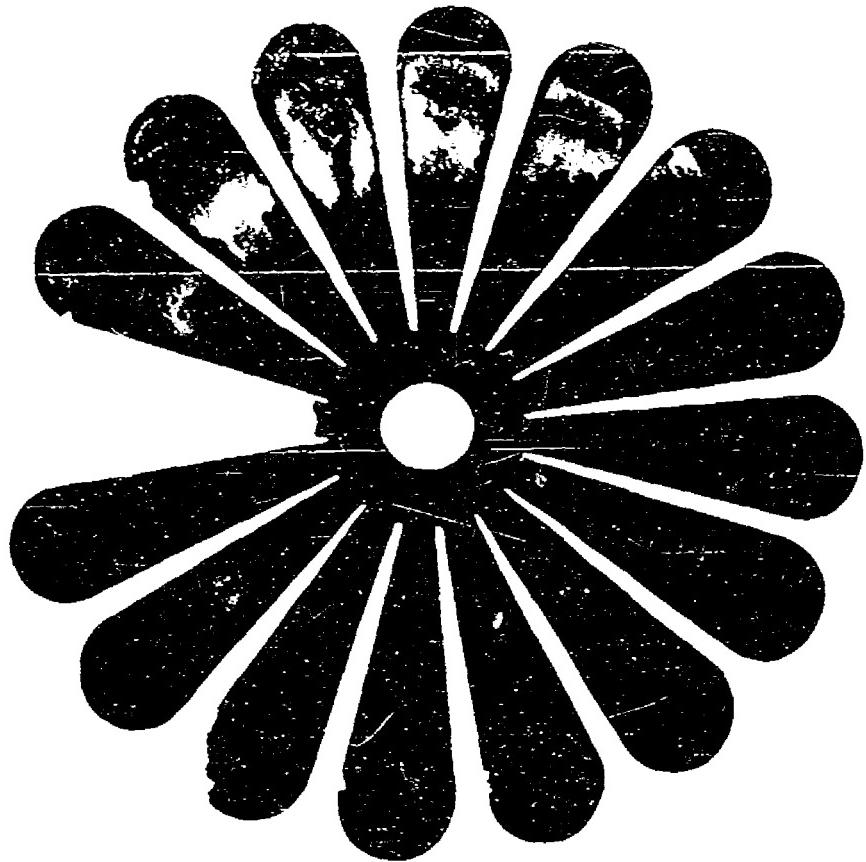
FIG. 10. E 19 R1 MECHANICAL SMOKE GENERATOR
- PETAL VALVE WHICH FAILED AFTER A
WORKING PERIOD OF 42 HOURS.

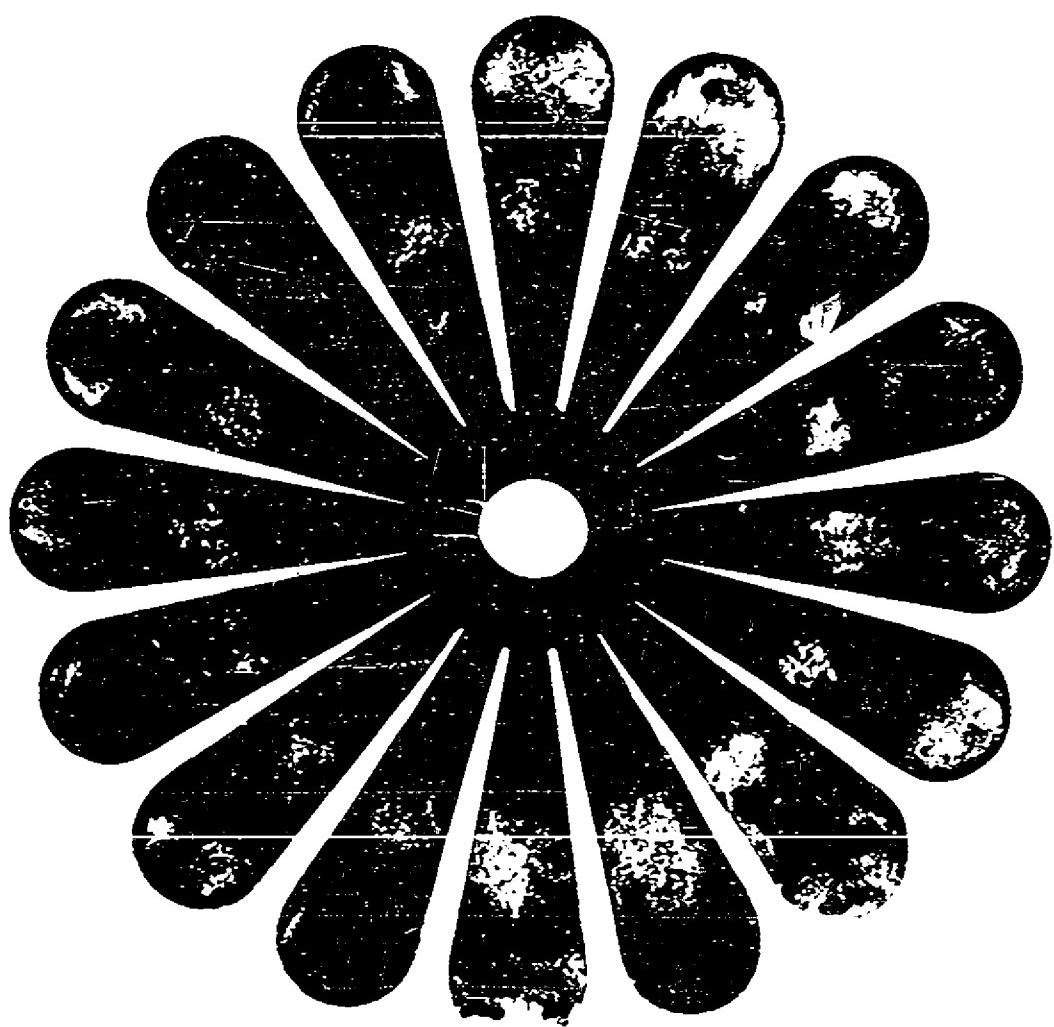
FIG. II E19RI MECHANICAL SMOKE GENERATOR
- PETAL VALVE WHICH FAILED AFTER
A WORKING PERIOD OF 3¹/₂ HOURS.

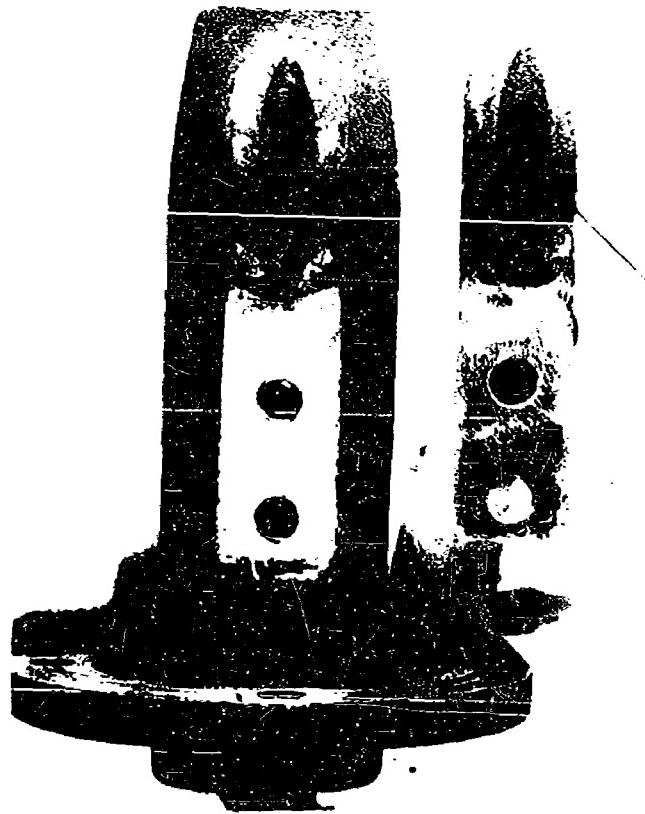
FIG. 19 E19RI MECHANICAL SMOKE GENERATOR
-DEPOSITION OF CARBON IN THE PRESSURIZING VALVE.

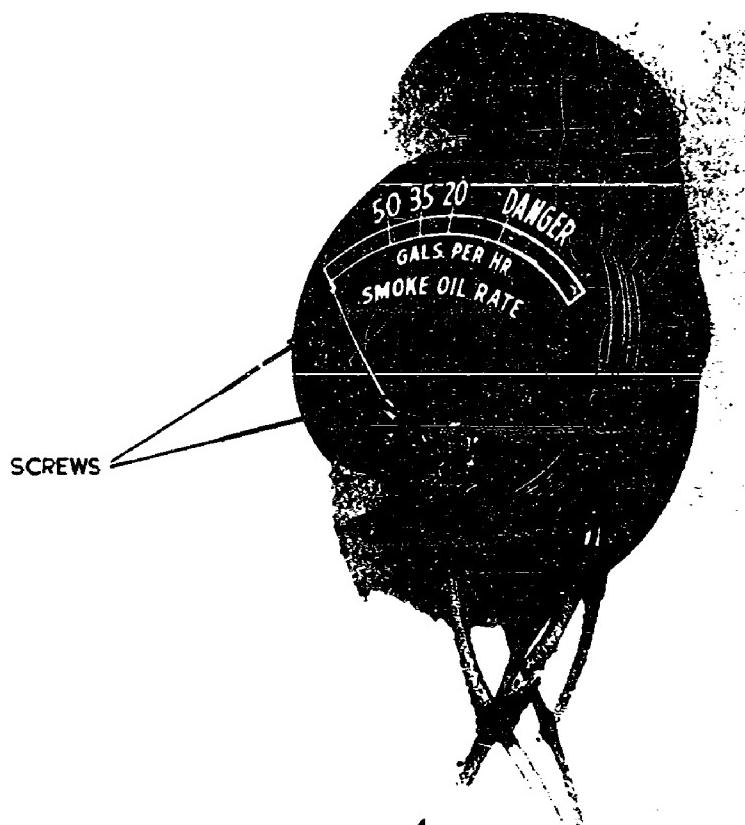
Time From Zero min.	Results
Zero	Test commenced.
Z + 5	Flow meter became loose in its case (Fig. 20).
Z + 8	Pressure gauge needle dropped off its pivot (Fig. 21).
Z + 13	Petrol tank sustained a fracture (Fig. 22) and contents drained out.
Z + ? (Stop watch failed).	Petrol pipe connection to float chamber broke off at the coupling (Fig. 23).
Z + 20	Test completed.

FIG. 20 E19RI MECHANICAL SMOKE GENERATOR
- FLOWMETER AFTER "BUMP" TEST. (NOTE THE SCREWS.)

The loosening of the flow-meter in its case (see Table 1) could be readily overcome, by cementing the retaining screws in position.

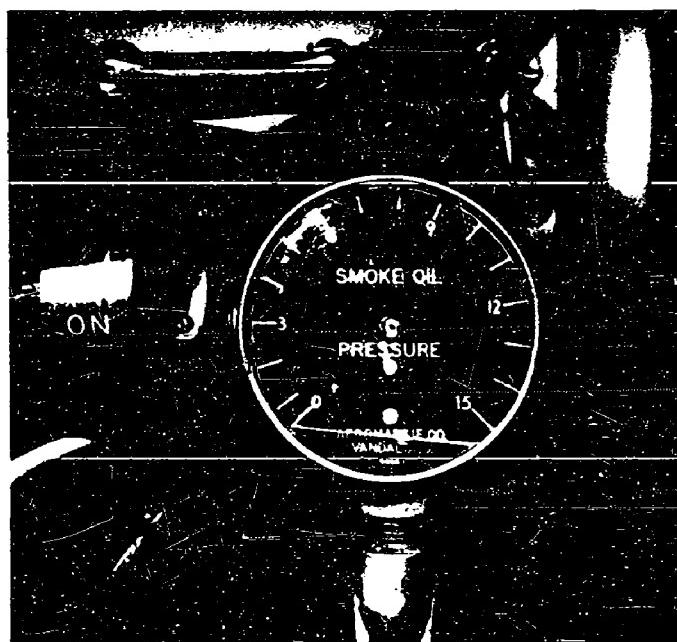
FIG. 21 E19RI MECHANICAL SMOKE GENERATOR
- PRESSURE GAUGE AFTER "BUMP" TEST

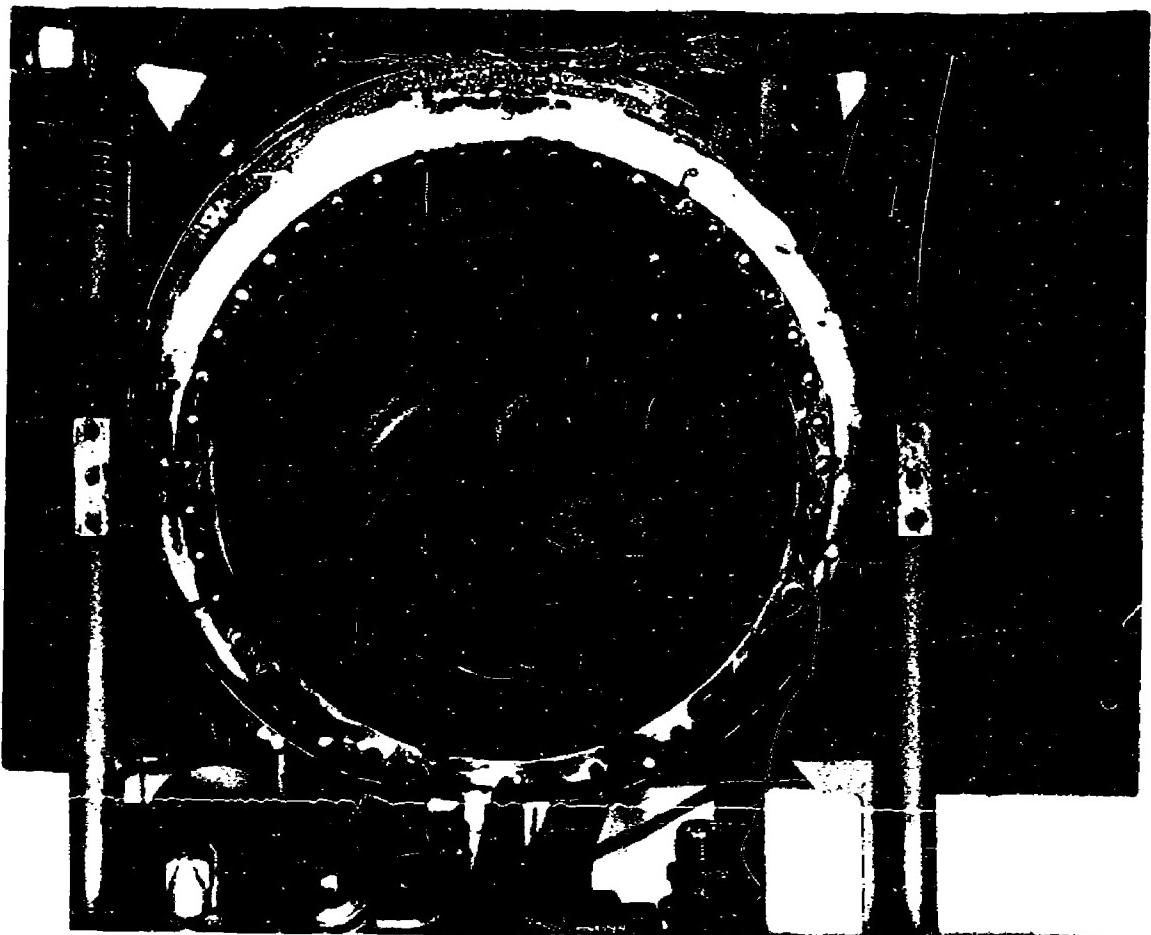
1. The float bowl assembly had worked loose.
2. The flexible petrol pipe had developed a fracture.
3. The glasswool constituting the lining had settled into the lower portion of the shell (Fig. 24).

FIG. 24. E19RI MECHANICAL SMOKE GENERATOR
- POSITION OF GLASS WOOL LINING AT
THE COMPLETION OF THE "BUMP" TEST.

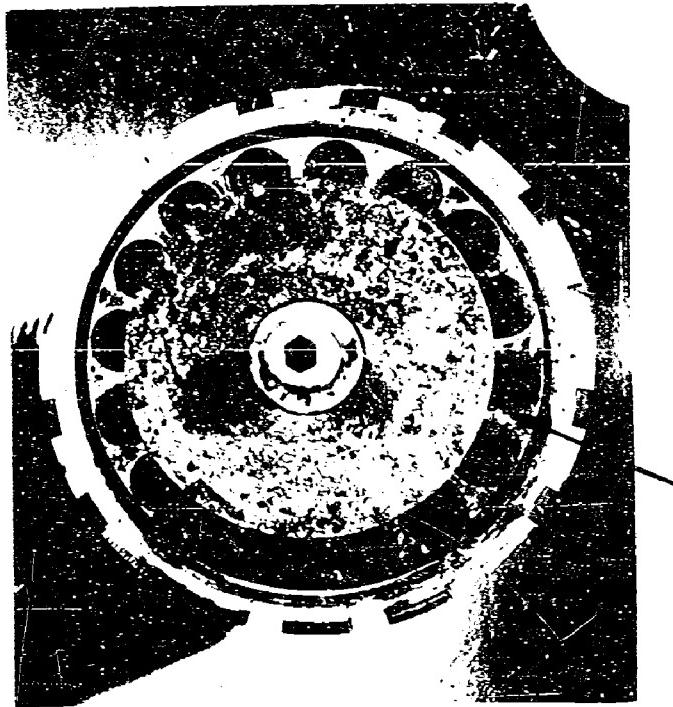
FIG. 25 E19RI MECHANICAL SMOKE GENERATOR
FAULTY ENGINE HEAD EX TEST N° 5 (→)

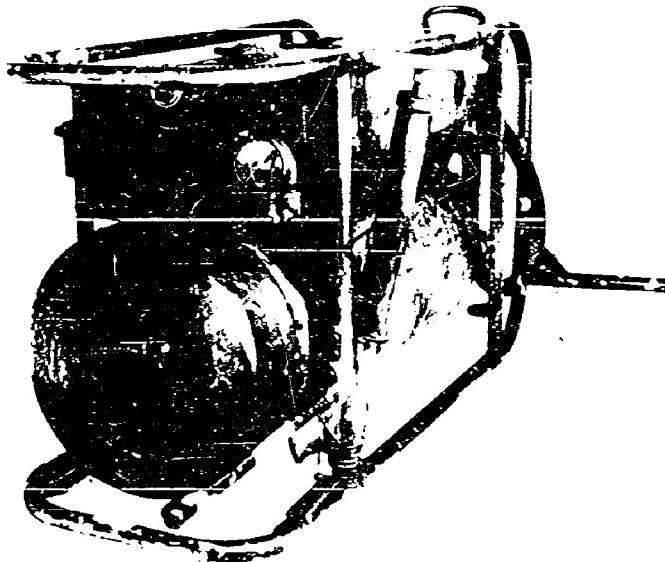
At the completion of Test No.7 the Generator was returned to the Dry Heat Chamber for a period sufficient to ensure that the machine would be thoroughly dried out. A visual inspection of the component parts of the unit was then made and the machine was operated in the open for a period of ten minutes. No fault could be found and the Generator operated satisfactorily. A photograph of the Generator as it appeared at the completion of tests (i) to (viii) is reproduced in Fig.26.

FIG. 26 E19RI MECHANICAL SMOKE GENERATOR
- APPEARANCE AT THE END OF THE
CLIMATIC CYCLE TESTS.
